**Quality Assurance In Radiography With Emphasis On Light Field X-Ray Beam Alignment****Bonaventure C.Alumona<sup>1</sup>, Margaret I. Ike-Ogbonna<sup>1</sup>, U.A.I. Sirisena<sup>2</sup>, Franklin D. Akpolile<sup>2</sup>**<sup>1</sup>**Department of Physics, University of Jos, Nigeria**<sup>2</sup>**Radiology Department, Jos, University Teaching Hospital, Nigeria**Kelvinchuka9435@gmail.com [ikeogbonnaijeoma@yahoo.com](mailto:ikeogbonnaijeoma@yahoo.com), palfranko@yahoo.com**ABSTRACT**

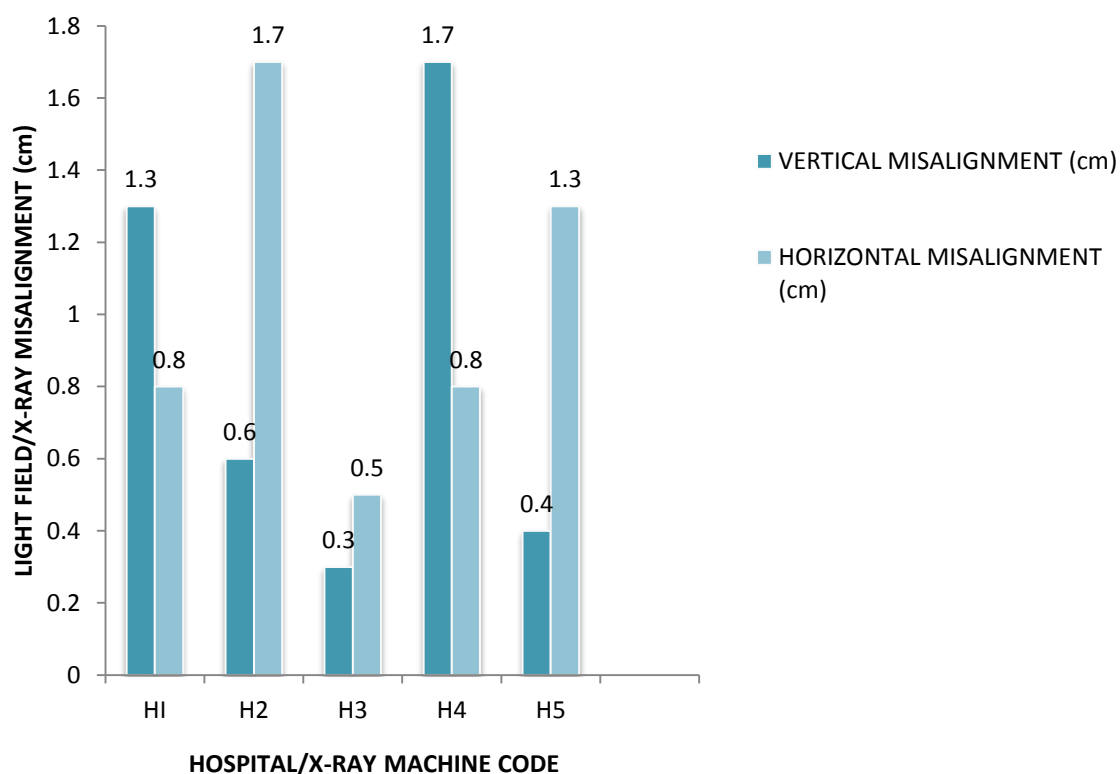
**Figure1: A Bar Chart Representing the Light Field/X-Ray beam Alignment Test Results on the 12.5 cm x 12.5 cm Collimator Light Field.**

Table 1 and Figure 1 represent the vertical and horizontal deviation of the light field and X-ray beam misalignments of the 12.5 cm x 12.5 cm collimator light field of the various X-ray centers, the percentage misalignment for the vertical axis were: 1.3, 0.6, 0.3, 1.7, and 0.4cm corresponding to H1, H2, H3, H4, and H5 respectively. While the percentage misalignment for the horizontal axis were: 0.8, 1.7, 0.5, 0.8, and 1.3cm corresponding to H1, H2, H3, H4, and H5 respectively. The most vertically misaligned (1.7cm) correspond to 1.7% of the source to the image distance (SID) was recorded on X-ray machine H4, while H2 recorded the most horizontal misalignment of 1.7cm corresponding to 1.7% of the source to the image distance (SID). H3 was seen to have the least misalignment of 0.3cm and 0.5cm on the vertical and horizontal misalignment test respectively. From the analysis, all X-ray machines observed passed the light field and X-ray beam misalignment test is having misalignments of values below the AAPM set limit of 2.5cm (2.5% of the SID) vertical and horizontal misalignment.

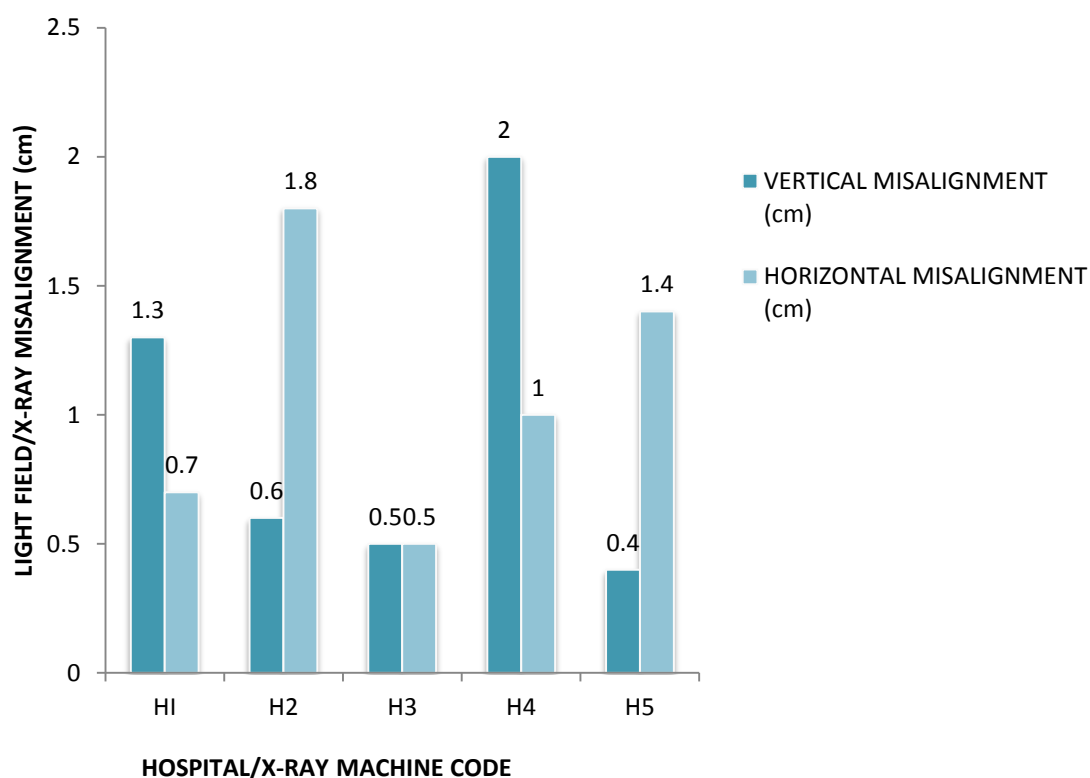
**Figure 2: A Bar Chart Representing the Light Field/X-Ray beam Alignment Test Results on the 22.5 cm x 17.5 cm Collimator Light Field.**

Table 2 and Figure 2 represent the light field and X-ray beam misalignment test using a larger collimator light field of 22.5 cm x 17.5 cm. It was observed that, H1, H2, H3, H4, and H5 had vertical misalignment of 1.3, 0.6, 0.5, 2.0, and 0.4cm, with a horizontal misalignment corresponding to 0.7, 1.8, 0.5, 1.0, and 1.4cm respectively. X-ray machines (H4 and H2) recorded the highest vertical and horizontal misalignment of 2.0cm and 1.8cm respectively corresponding to 2cm and 1.8cm of the source to the image distance (SID). Even though H4 recorded the highest misalignment value, this value was seen to be below the AAPM 2.5cm (2.5% of SID) set limit for vertical and horizontal misalignment. Hence H4 passed the light field and X-Ray misalignment test. The least misaligned as shown in figure 1 were H5 representing
